HIGH POWER MAGNETOHYDRODYNAMIC SYSTEM

MAXWELL LABORATORIES, INC.
200 WEST CUMMINGS PARK
WOBURN, MASSACHUSETTS 01801

TECHNICAL REPORT AFAPL-TR-78-51, Volume II
Final Report May 1976 - June 1978

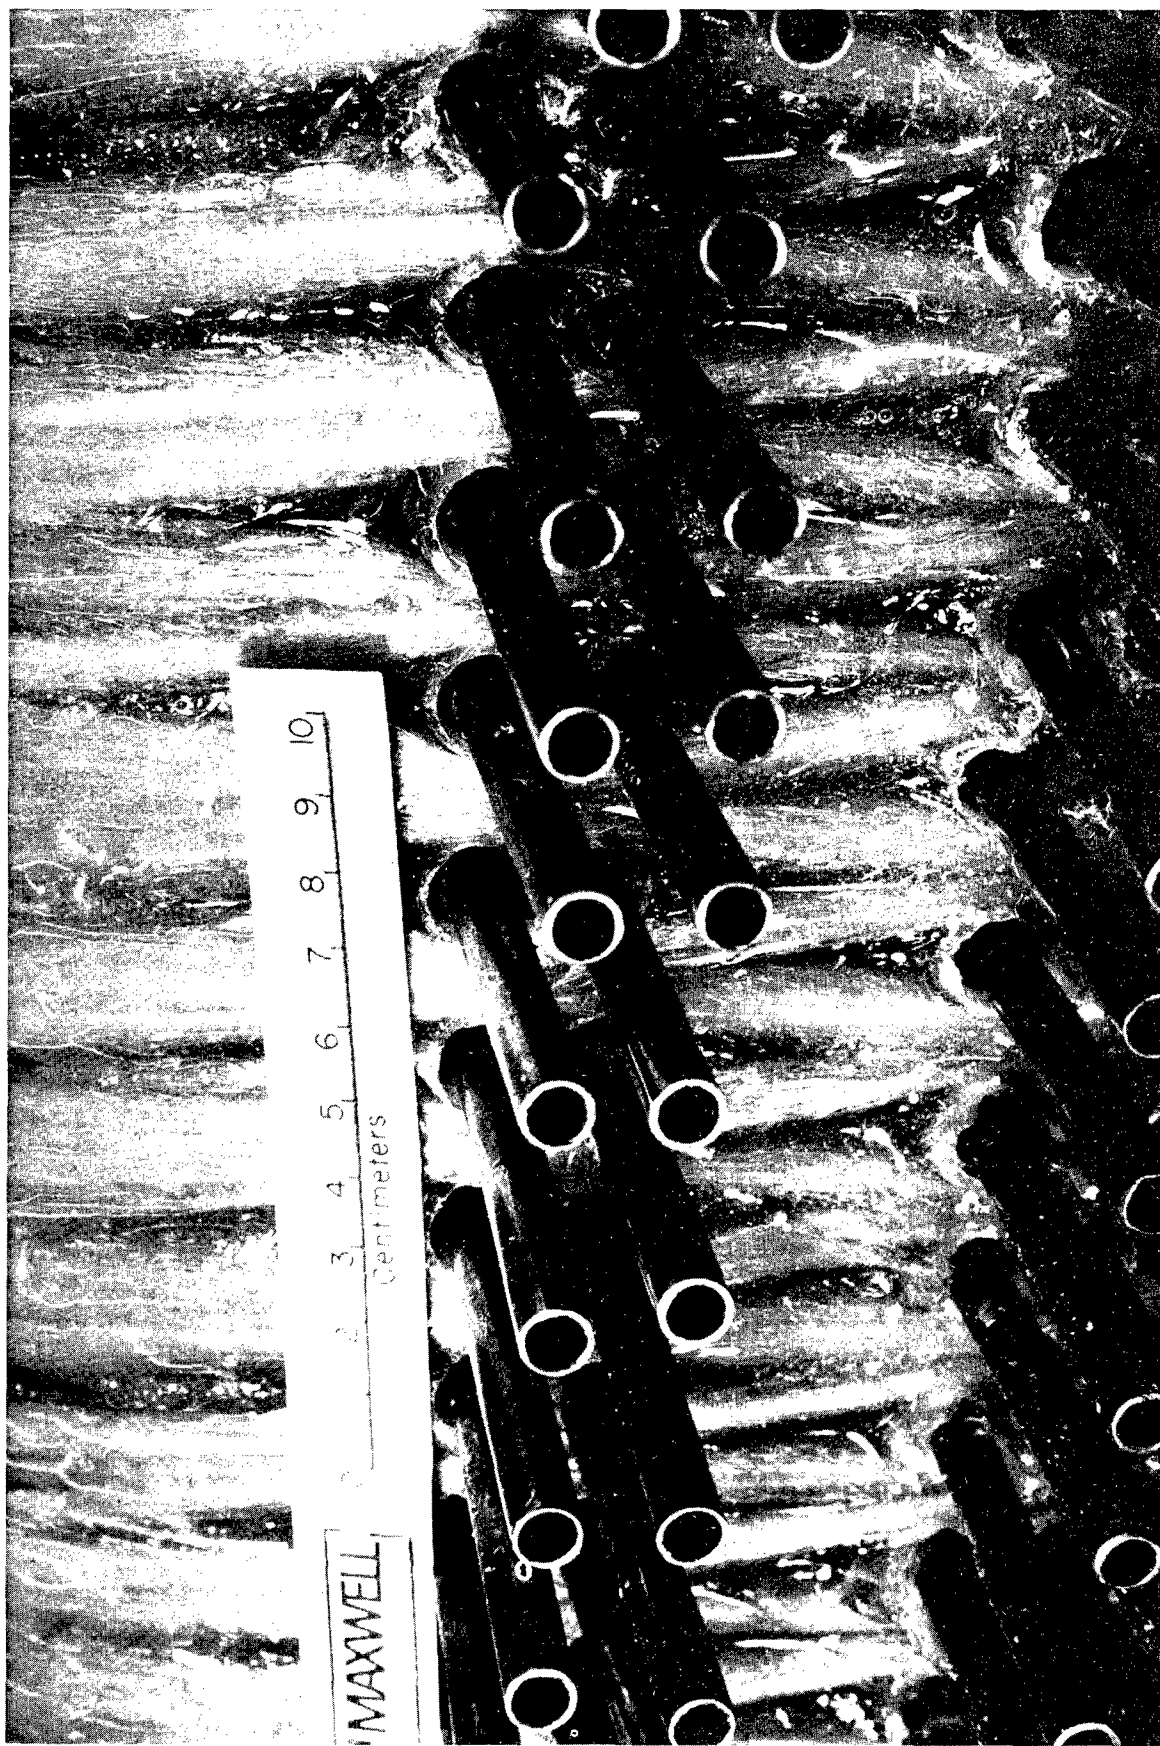
This task proved to be extremely difficult and was the most serious problem encountered during the channel fabrication. Initially, the mandrel end caps were easily removed. After one of the "constant width" mandrel sides had been moved inward away from the frames, an attempt was then made to tap out that side.

Figure 173. Removal of Tube End Seals.

However, the side would not move, and increased hammering only galled the aluminum. A relief on the tapered sides had been omitted. In addition, the "tapered sides" should have been sandwiched between the "constant width" sides rather than vice versa. To aid in the mandrel removal, dry ice was used to cool the mandrel section which was being removed. Although the section still had to be hammered out, the dry ice process worked. The frames were not damaged because the motion was between adjacent mandrel sides and not between the side and the frames. The second constant width side was more difficult to remove. Following several hours of chilling, this section still would not move, and galling became a problem. Finally, spreader bolts were used to gently expand the tapered side pieces, and after continued hammering, the section came out. The tapered sides were then easily removed. There was no apparent damage sustained during the mandrel removal process. Some voids were apparent in the ceramic. These were readily repaired. During the initial inspection, the alumina appeared very weak and brittle, easily scraped with a knife. Subsequent application of heat via heat lamps hardened the alumina. Apparently, while the outside of the ceramic had hardened, the unexposed surface against the mandrel had not.
